# ArcelorMittal

## Manalapan Seawall Storm Protection/Erosion Control Palm Beach, Florida | USA

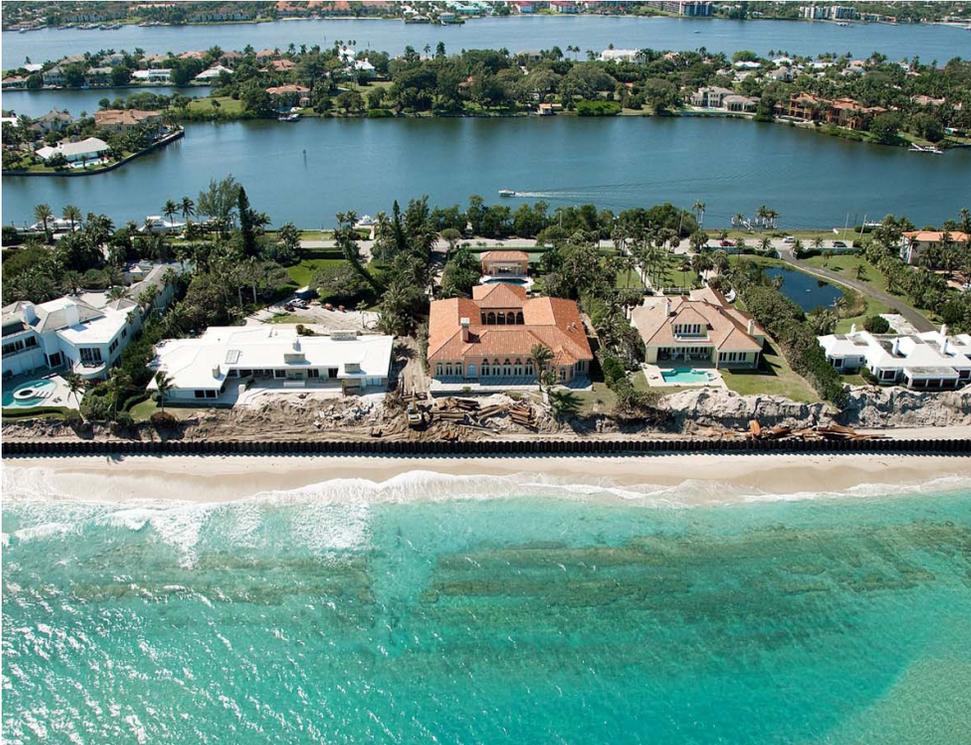
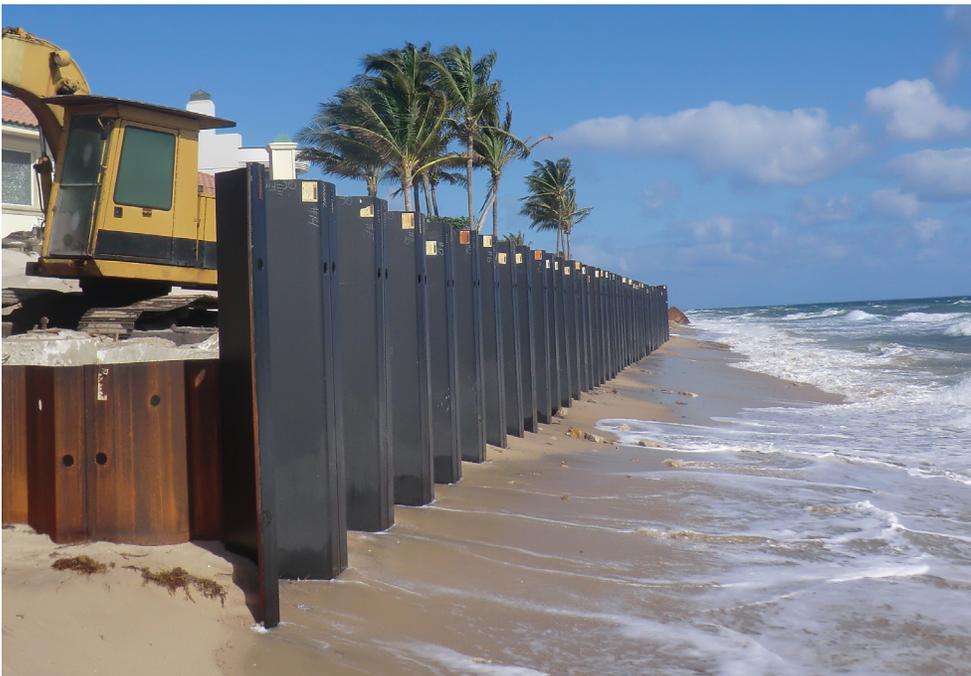
In the 1960s, residents sought to protect the nearly 170 oceanfront properties against the ocean's surge by constructing sea walls of PMA 22 steel sheet piles driven into the beach sand with steel tiebacks anchored to concrete deadmen approximately 10 to 12 feet inland.

In Manalapan, the sea water overtopped the sea walls, washed away the soil, exposed the concrete deadmen and the steel tieback anchors snapped. With its support system compromised, the steel sheet piles failed and fell toward the ocean. Sea water flooded the oceanfront properties and caused significant damage to the prime real estate.

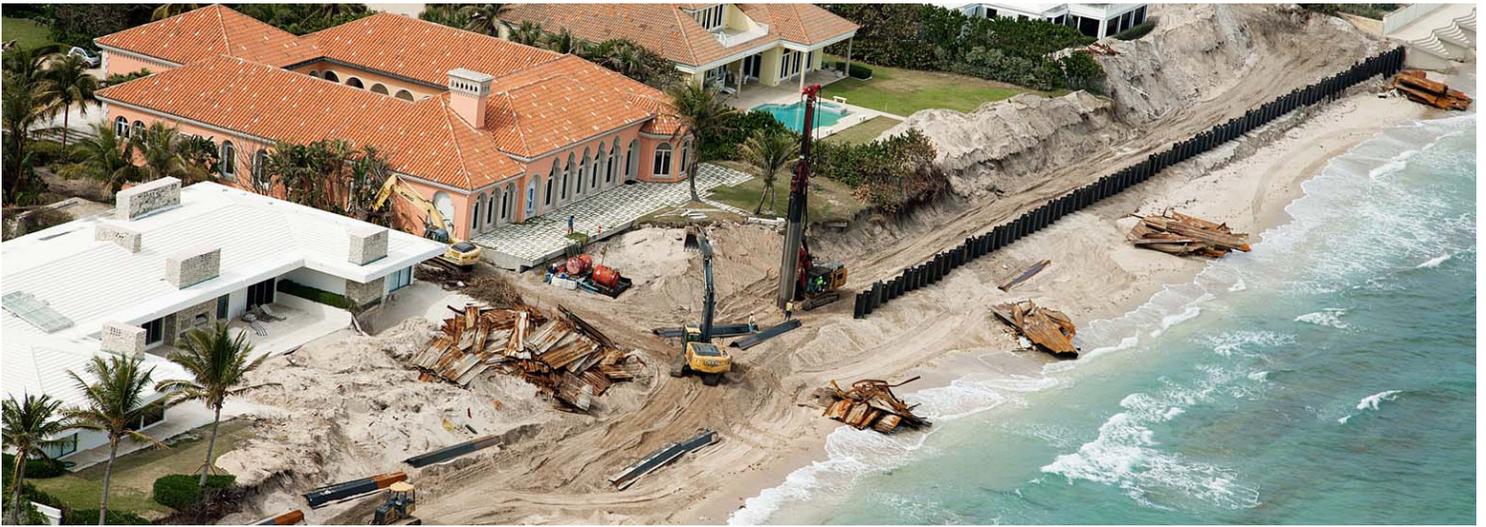
In a majority of the ocean-side properties, the design consisted of a T-wall, with the main wall at a height of 8 feet above the mud line, an increase from the previous height of 5 feet. To stabilize the sea wall, shorter steel sheet piles were driven into the limestone at 28 ft to 30 ft

depth perpendicular to the main wall, connected via C9 corner sections.

As the stabilizing sheets got further inland, shorter lengths of sheet pile were needed.

Steel sheet piles, having proved the 50-year life rating from the first installation, were chosen again, but this time the product selected for the main sea wall was coated AZ 26-700 at a thickness of 0.48 in (with a 100-year design life).
