# Manalapan Seawall

Storm Protection/Erosion Control  
Palm Beach, Florida | USA

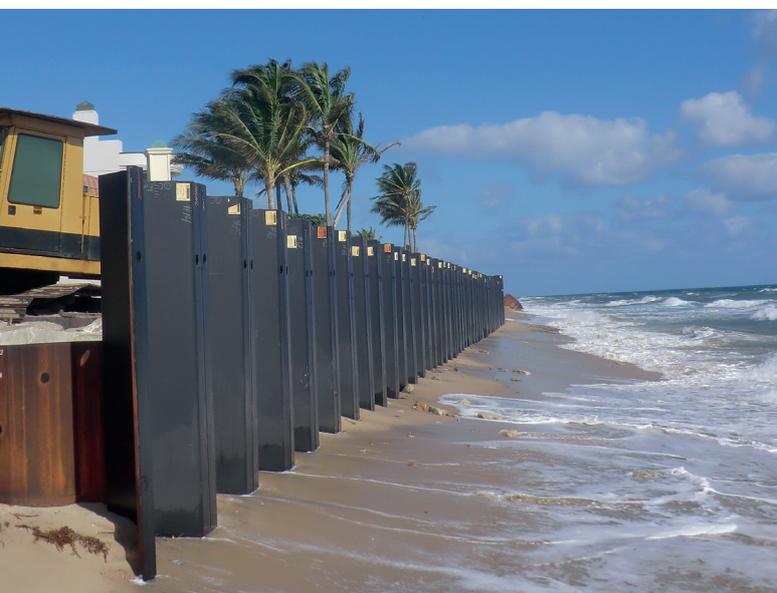
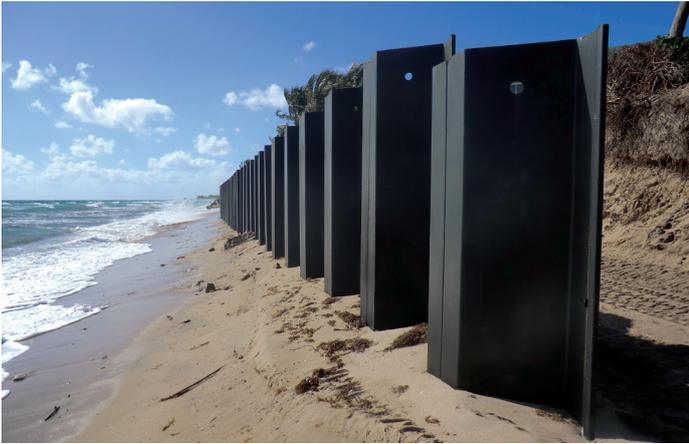
In a majority of the ocean-side properties, the design consisted of a T-wall, with the main wall at a height of

2.5 m above the mud line, an increase from the previous height of 1.5 m. **To stabilize the sea wall, shorter steel sheet piles were driven into the limestone at 8.5 to 9.0 m depth perpendicular to the main wall, connected via C9 corner sections.**
